SAFETY ALERT

Date of Incident	Ausjet Committee of management Meeting 19 th March 2015.
Region	Australasia
Type of Incident	A high pressure water injection injury to an operator may occur due to the current positioning of the weep holes on M24 fittings. (see RHS Photo below)

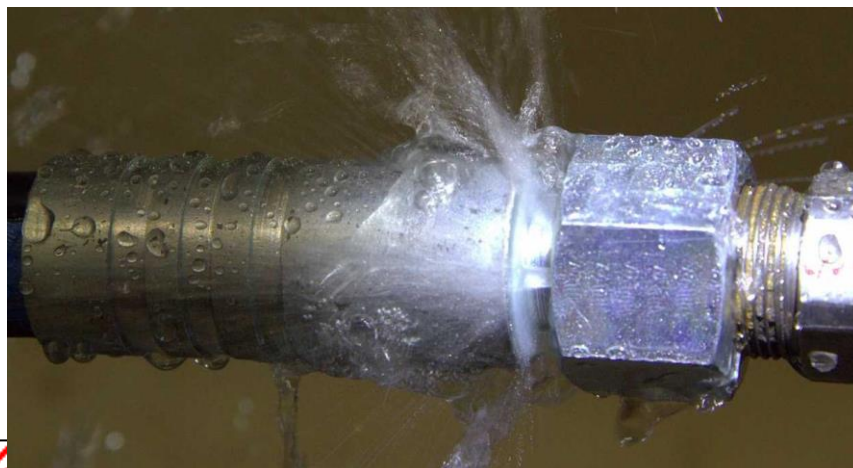
Description of Incident	During the last 12 months High Pressure Water Jetting Hoses with M24 fittings have been found with weep holes on the side of the hose nut. This has raised concern due to the potential for water injection injuries in the event of a hose fitting leakage.
-------------------------	--

What Immediate Action	<p>Ausjet have contacted the hose suppliers to inform them of the potential for a high pressure water injection injury due to the positioning of the weep holes.</p> <p>It is advised that companies and operators inspect all hoses and fittings, ensure connections are suitably tightened and personnel are informed about the positions of weep holes.</p> <p>Using pressure hose fittings with weep holes that run along the hose is a safer alternative. (see photo at the bottom of the alert).</p> <p>Serious high pressure water injection injuries have occurred in the past from weep holes positioned as per the RHS photo below</p>
-----------------------	---
