INCIDENT ALERT

Date of Incident	13/10/12
Type of Incident	Near miss

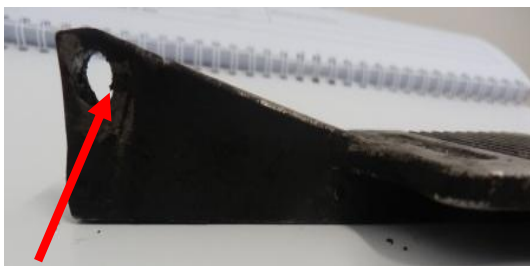
Ongoing regular mechanical checks can identify components that show signs of possible failure including on foot pedals visible damage, scoring and sloppiness in the pivot pin.

Elongation of pivot hole shown on foot pedal.

What Immediate Action	<ul style="list-style-type: none">➤ Job stopped immediately and foot pedal changed out➤ Internal Safety Alert issued company wide➤ Foot pedal returned to manufacturer for metallurgical testing and advice on what happened
-----------------------	--

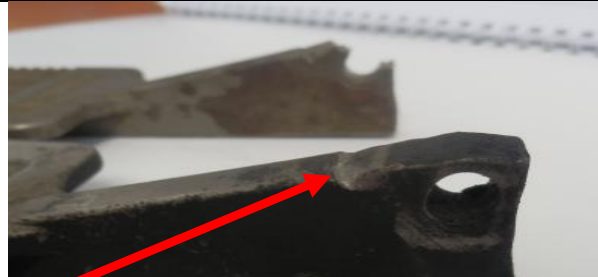
Deep scoring on the top of the foot pedal.
