# INCIDENT ALERT

| Type of Incident | Lost time injury |

| Description of Incident | A maintenance crew was tasked with high pressure water jetting a sewer main. |

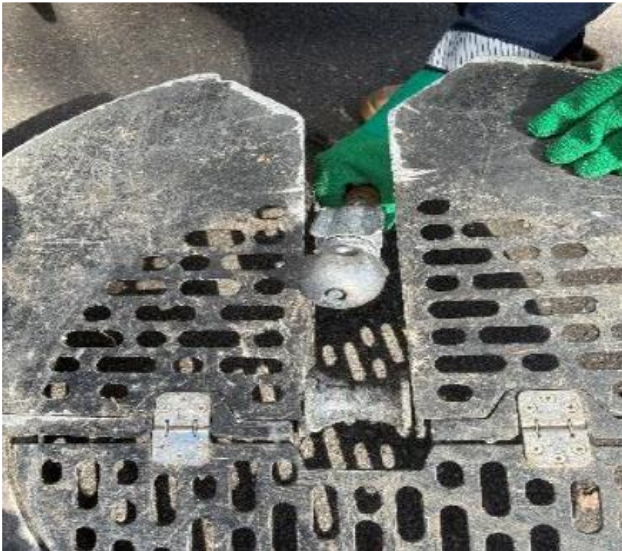
| What Was Person Doing | Jetting was performed from an upstream/full maintenance chamber due to misinterpretation of flow direction.<br>The jetting nozzle was not completely inserted into the pipe, causing the hose to turn and recoil out of the safety grate. |
| What happened unexpectedly | The hose nozzle unexpectedly recoiled out of the maintenance hole, out of the installed safety grate and struck the hose operator's upper right chest and armpit. |

Safety grate and nozzle

| Engineering | A design review of the safety grate is underway. |

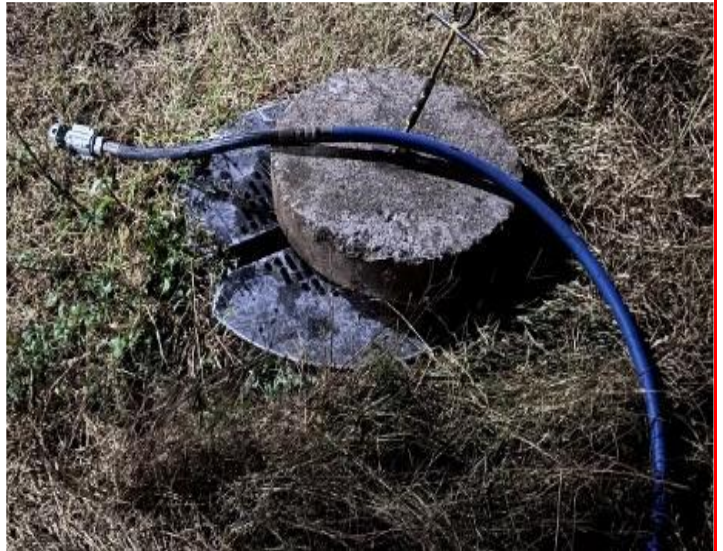
Hose, nozzle, grate and maintenance hole cover
