# High pressure water jet injection injury

Mines safety alert no. 321 | 08 February 2016 | Version 1

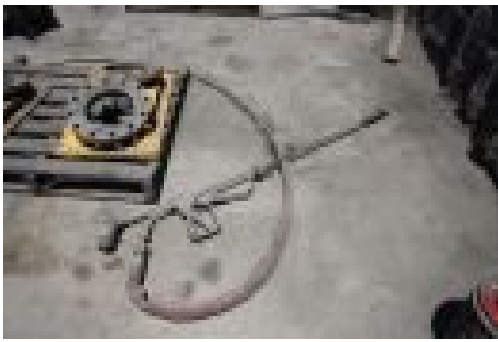
A worker conducting a pre-start check on a truck-mounted high pressure (28,000 psi) water jet blaster sustained a lower abdominal injury when the water jet blaster hose ruptured near the gun (photo 1) piercing the protective shroud on the hose (photo 2) and striking the worker. The worker was attended to by paramedics before being transferred to hospital for treatment.

The hazard in this case was high pressure water jet. The direct cause of this accident was the failure of the hose close to the gun, combined with a subsequent failure of the protective shroud designed to protect a worker in case of such an event. Other contributing causes included:

- The deteriorated condition of the hose and safety shroud was not identified - it was not specified in the pre-start checks and the protective shroud could not be easily removed.

- Due to no clear instructions on the correct storage of the hoses, operators followed poor storage practices, putting unnecessary strain around the failure point of the hose during storage.
- High pressure water jet activity was not considered a high risk activity and did not receive the focus it required.

- If high pressure water jet equipment is used on-site check the integrity of all hoses and safety relief systems. Also check that the hose and shroud specifications meet the required duty.
- Check that risks associated with high pressure water jet activities at the mine have been identified.
- Check that appropriate maintenance systems and training are in place for high pressure water jet operators and equipment.
