INCIDENT ALERT

Date of Incident	5 th January 2016
Type of Incident	Potential Injury

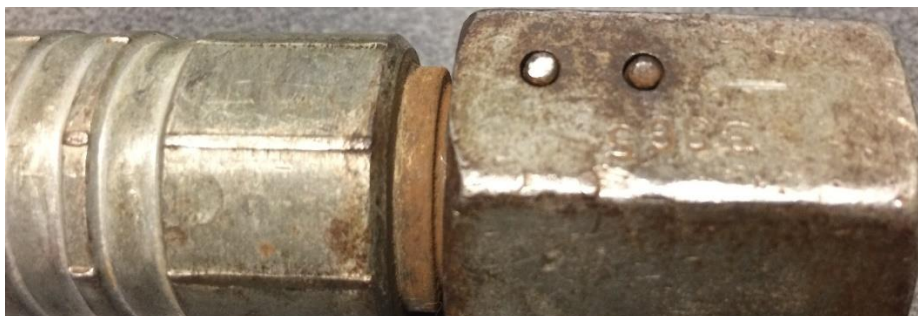
Time of Accident	8:00am
Result of Injury	N/A
Lost Days	N/A
Description of Incident	High pressure hoses were returned into yard for inspection. Upon inspecting a high pressure hose the technician identified that the hose was non-conforming to their company standards. The hose end had wire pins to hold nut to the hose insert, corrosion in the pins can result in the nut and hose parting.
What Equipment Category	750bar high pressure hose.
Equipment Used	
What happened unexpectedly	
What Was Person Doing	Completing an onsite hose inspection.

What Immediate Action	Hose tagged out of service and quarantined
-----------------------	--

Elimination	Any non-conforming high pressure hoses to be re-ended or if sub-standard destroyed.
Substitution	
Isolation or barriers	
Engineering	
Administration	Further inspection of all company hoses
PPE
