INCIDENT ALERT

Date of Incident	26 th May 2016
Type of Incident	Laceration requiring Medical treatment

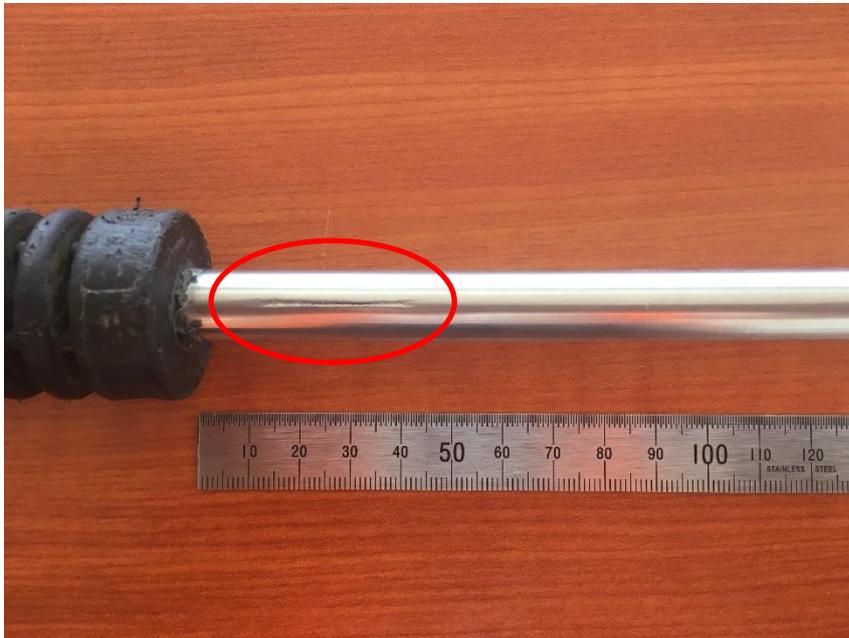
Time of incident	7.10pm
Result of Injury/Damage	Hospital out patients
Lost Days	None
Description of Incident	HPWJ laceration to hand
What Equipment Category	Hired in Class B (low level)
Equipment Used	HPWJ Gun
What Was Person Doing	The HPWJ operator was using a HPWJ gun to clean calcium build up inside of large concrete water tanks. Due to using 345 Bar (5000psi) and being a tall person, He was holding the gun lance just in front of the fixed handle for comfort and control.
What happened unexpectedly	The lance split under the pressure and High pressure water emitted from the barrel injecting water into the operator's hand. Upon inspection it was determined that the lance had a section that showed a 30mm split where the operator was holding the lance at that point causing the injury.

What Immediate Action	Task stopped, Person taken for medical attention, the hirer of the HPWJ Unit was notified and the unit and accessories were taken out of service, investigation process started. Machine and worksite was audited by an Independent Auditor to ensure all complied for the type of work that gets carried out regularly and it was found that both the hirer and site were not fully compliant for safe operation. The hire company identified in the investigation the lance was an old stock seam welded barrel and not rated to the machine pressure.
-----------------------	--

Figure 1: 30mm Split in the Lance Tube.

Elimination	All existing barrels were examined and any seam welded barrels removed from service. Audit results caused a re-assessment of QA and prestart checks for both the hirer and worksite.
Substitution	
Isolation or barriers	
Engineering	
Administration	Pre-start checks at the start of every shift
PPE	All correct PPE now in place

Prior preparation prevents poor performance and ensures safe operation of class B equipment. The Independent Auditor audit resulted in some very important learning in regards to the AS/NZ 4233.1 & 2 standard requirements which were not common knowledge for the hirer and worksite. Injured worker was back at work the next day and all involved were a lot more knowledgeable around Class B operating requirements. It also prompted the customer to do a full audit on all their current installations.
