INCIDENT ALERT

Date of Incident	29/1/2016 (from Canada)
Type of Incident	Lost Time

The Enform safety alert is #03-2016

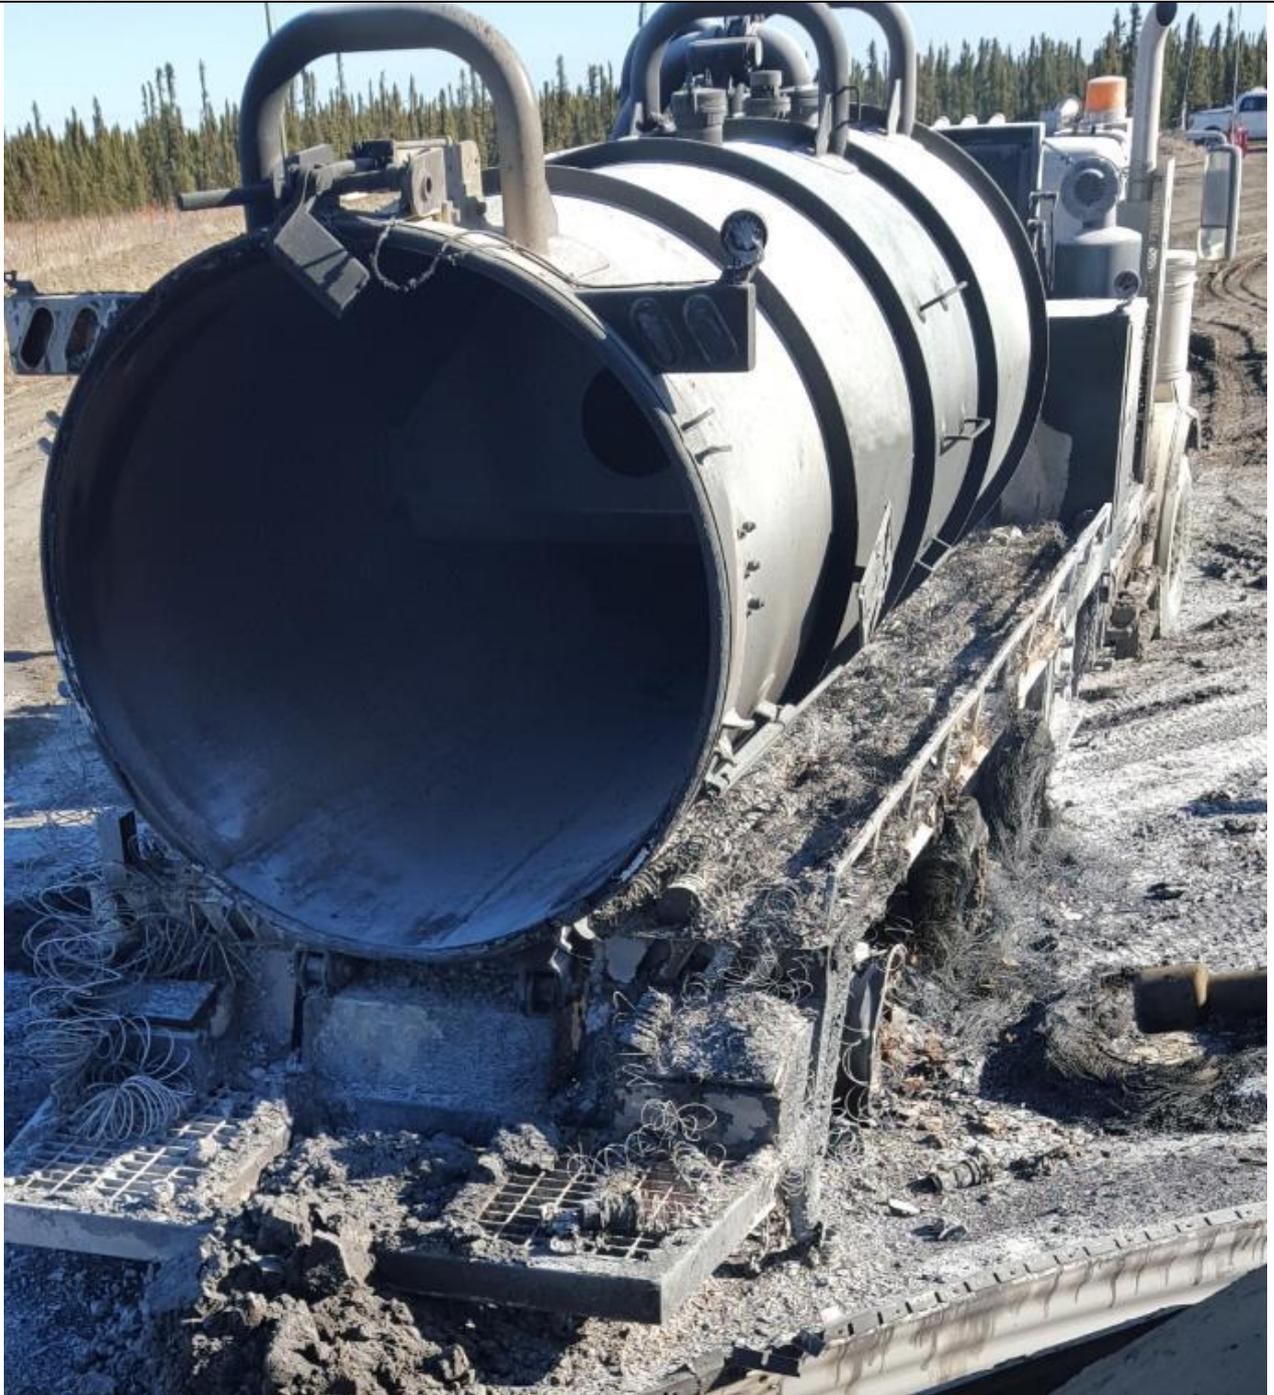
Photo on page 3.

What happened unexpectedly	The blower and associated rubber hose overheated igniting the residual hydrocarbons in the blower's associated hose and piping.
----------------------------	---

What Caused the incident	<ul style="list-style-type: none"> • The blower and associated rubber hose overheated igniting the residual hydrocarbons in the blower's associated hose and piping. • An inspection revealed residual hydrocarbons were present in the blower's associated hose and piping on this vacuum truck as well as others. • The blower and associated hose and piping can overheat such as when the blower is operating at maximum for an extended time or when under a load. Testing conducted on other trucks identified temperatures beyond the manufacturer's maximum temperature for the rubber hose. • A review of the blower manufacturer's documentation revealed that the blower was not designed for use with flammable liquids despite the integrated presence of a diesel flush system on this truck and similar trucks in the upstream oil and gas industry.
--------------------------	--

Destroyed Vacuum Truck

Engineering	A temperature sensor was installed on the hot side of the blower and the sensor was equipped with an audible and visual alarm.
--------------------	--

Administration	<ul style="list-style-type: none"> • Operators were equipped with and trained on the use of infrared temperature meters. • A procedure was instituted to cycle the blower on and off between 10 and 12 psi to reduce heating. • A procedure for the inspection of the diesel flush line was created. This was not a contributing factor, but it was felt that this warranted additional focus. • The inspection of internal piping and hoses for residual hydrocarbons was added to the regular maintenance schedule. • Refresher training was given to operators on emergency response procedures.
-----------------------	--

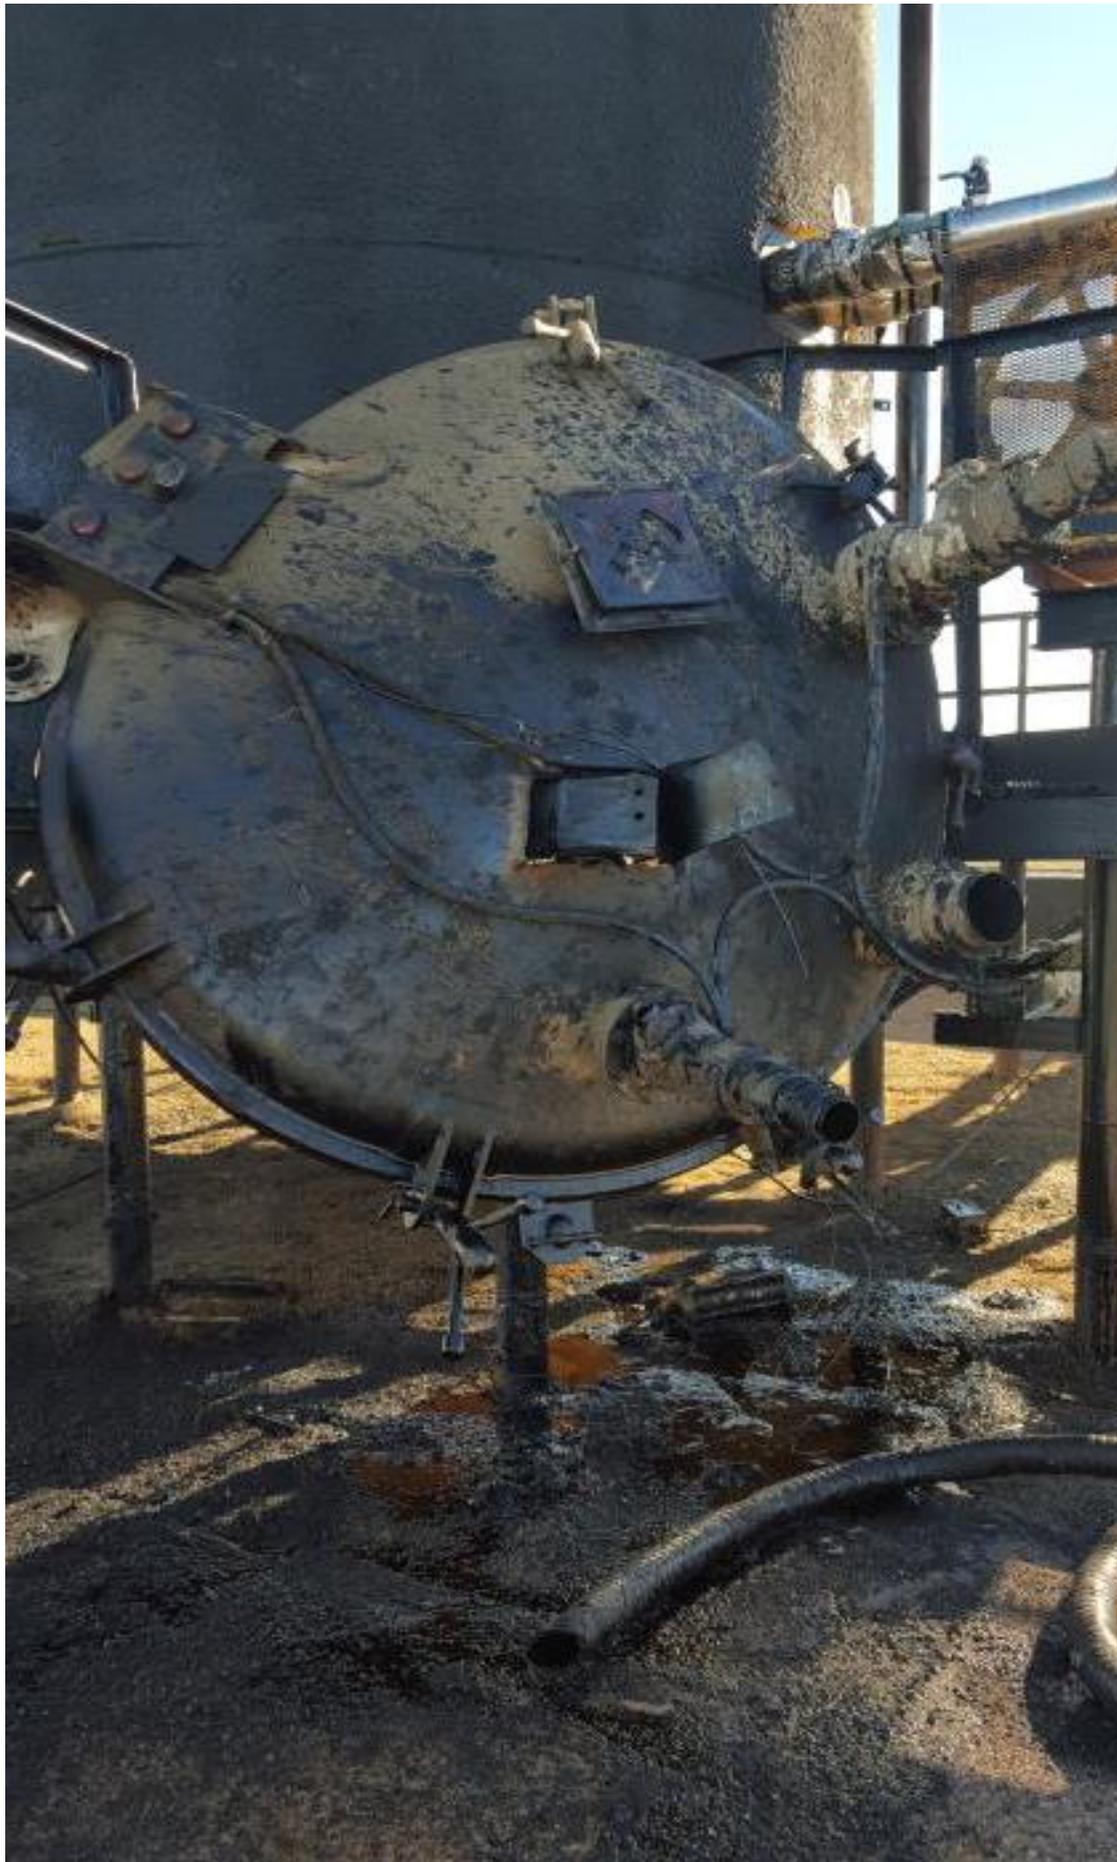
Photo on page 4.

Vacuum Truck Lid Resting Against Production Tank
