INCIDENT ALERT

| Description of Incident | Drain cleaning operator was struck on the head by a drain cleaning pressure hose that had failed at a joint coupling. |

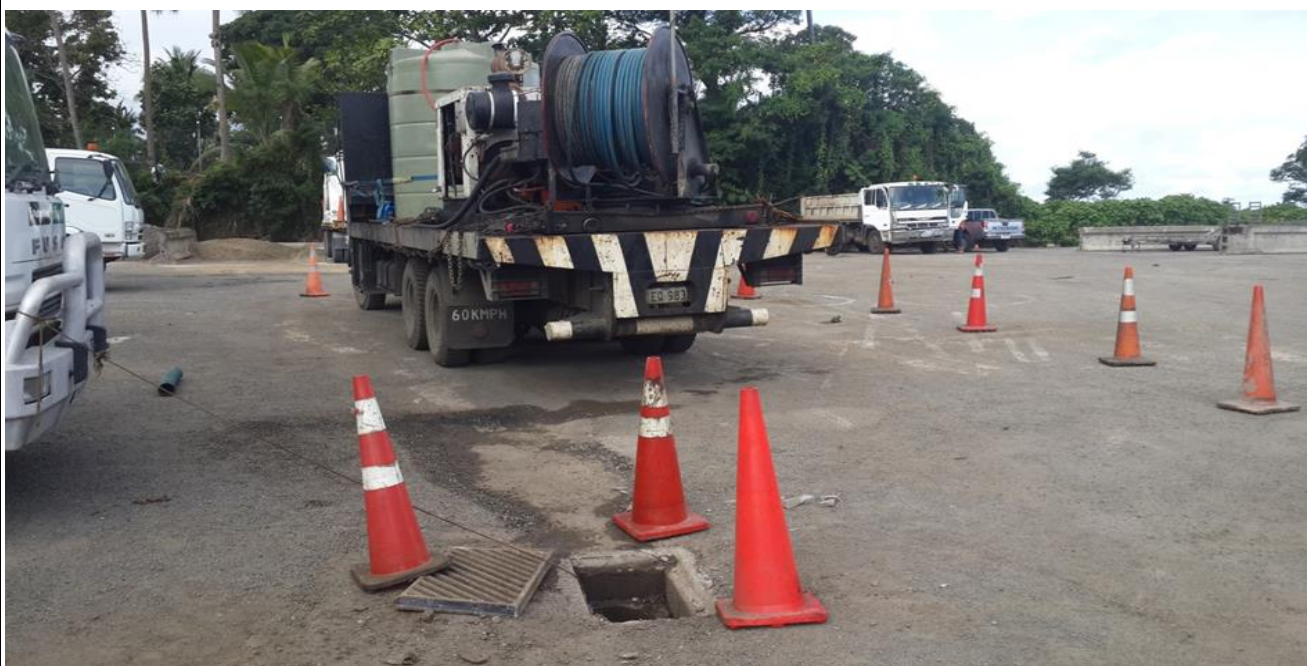
| What happened unexpectedly | At the time of the incident the HPWJ system was pressurised to around 207 bar (3,000psi). The hoses were an orange hose which was rated at 173bar (2,500psi) and a blue hose which was rated at 207bar (3,000psi). The orange hose failed at the ferrule joint of the hose coupling. The hose failed as it was being reeled in (under pressure and tension) due to the pressure and load exerted. The remaining hose and connectors (still attached to that end of the hose) whipped back striking the operator on the right side of his head while he was standing at the controls by the truck hose reel. The hose assemblies had been repaired some eight days earlier but had not pressure tested to any standard. There were four joints on the two pressure hoses. |

| Causal Factors: | <ul style="list-style-type: none"> • Use of a hose rated under the maximum operating pressure; • Connector joints (ferrules) not tested or certified after repair; • Damaged pressure relief gauge; • No operator protection from hose burst line of fire; • Lack of formal SOP • Lack of operator training; • No hard hat worn and/or protection from 'line of fire'. |

| Substitution | Retraction of the hose under pressure should be done via a remote control that allows the operator to be removed from the direct line of the activity. |

| Engineering | For all underground water jetting there shall be one long continuous length of pressure hose (generally around 100 metres) and a much shorter sacrificial leader hose around 3 metres that is connected to the nozzle, because whip socks are not practicable in this situation. |
| Administration | Suppliers and subcontractors demonstrate their compliance with AS/NZ 4233 prior to engagement. Where on pre-inspection a hose has joins other than to the leader hose the equipment is to be removed from site until a new hose can be fitted, or further controls are implemented such as exclusion zones that are greater than the exposed length of hose. For work using pressurised hoses in all other applications, hose joints and connections must be controlled with whip socks. |
