# INCIDENT ALERT

Date of Incident	8/11/13
State	Vic
Type of Incident	Incident Causing Injury (No Lost Time)

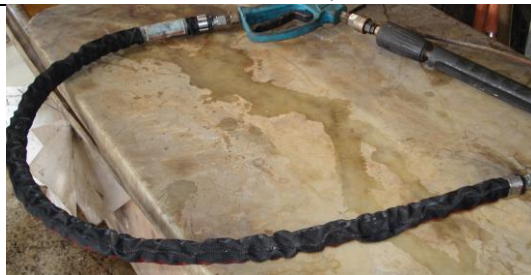
Time of Accident	13:130pm
Result of Injury	Doctor Only
Lost Days	Nil
Description of Incident	Whilst in operation a Class A pressure hose ruptured near the ferrule. Hot water struck the operator on his right hip. The pressure hose was inspected prior to use and was deemed serviceable.
What Equipment Category	Class A hot water pressure wash
Equipment Used	Gun
What happened unexpectedly	The pressure hose ruptured near the gun
What Was Person Doing	Pressure washing floor and surrounding areas.

The mixture of hot water and low pressure can still cause harm to the operator.

What Immediate Action	Immediate releasing of the hold to activate device Shutting the unit down Reporting of incident Medical attention Incident investigation started.
-----------------------	---

Elimination	
Substitution	
Isolation or barriers	Procure a protective sleeve for all hoses used on Class A systems to protect operator from being burnt in the event of hose failure.
Engineering	
Administration	Obtain test certificates with all new hoses to determine age of hose and ensure hose has been batch-tested An investigation was conducted and an internal safety alert issued. Develop a preventative maintenance system for testing of hoses (12 monthly testing) Upgrade pre-start checklist to include critical checks in accordance with Australian Standards
PPE	Reinforce the wearing of wet weather gear for all pressure wash activities
