INCIDENT ALERT

Time of incident	1330
Result of Injury/Damage	The worker suffered an orbital fracture and vision impairment
Lost Days	12 minimum
Description of Incident	Hit in face with end of 25mm sewer hose with a not – fit - for - purpose reducer attachment fitted on end of hose
What Equipment Category	Industrial Services Combination Vehicle
Equipment Used	Industrial Services Combination Vehicle equipped with Vacuum and Low pressure high volume sewer hose
What Was Person Doing	Cleaning a wash down sump utilising an Industrial Combination Vehicle
What happened unexpectedly	Whilst vacuuming sump, the 25mm sewer hose was used to provide wash down water. A reducer was used on end of sewer hose to provide a stream of water. The reducer being used was not - fit - for - purpose. Rubber washers in reducer fitting have blocked outlet resulting in pressure build up and loss of control with sewer hose.

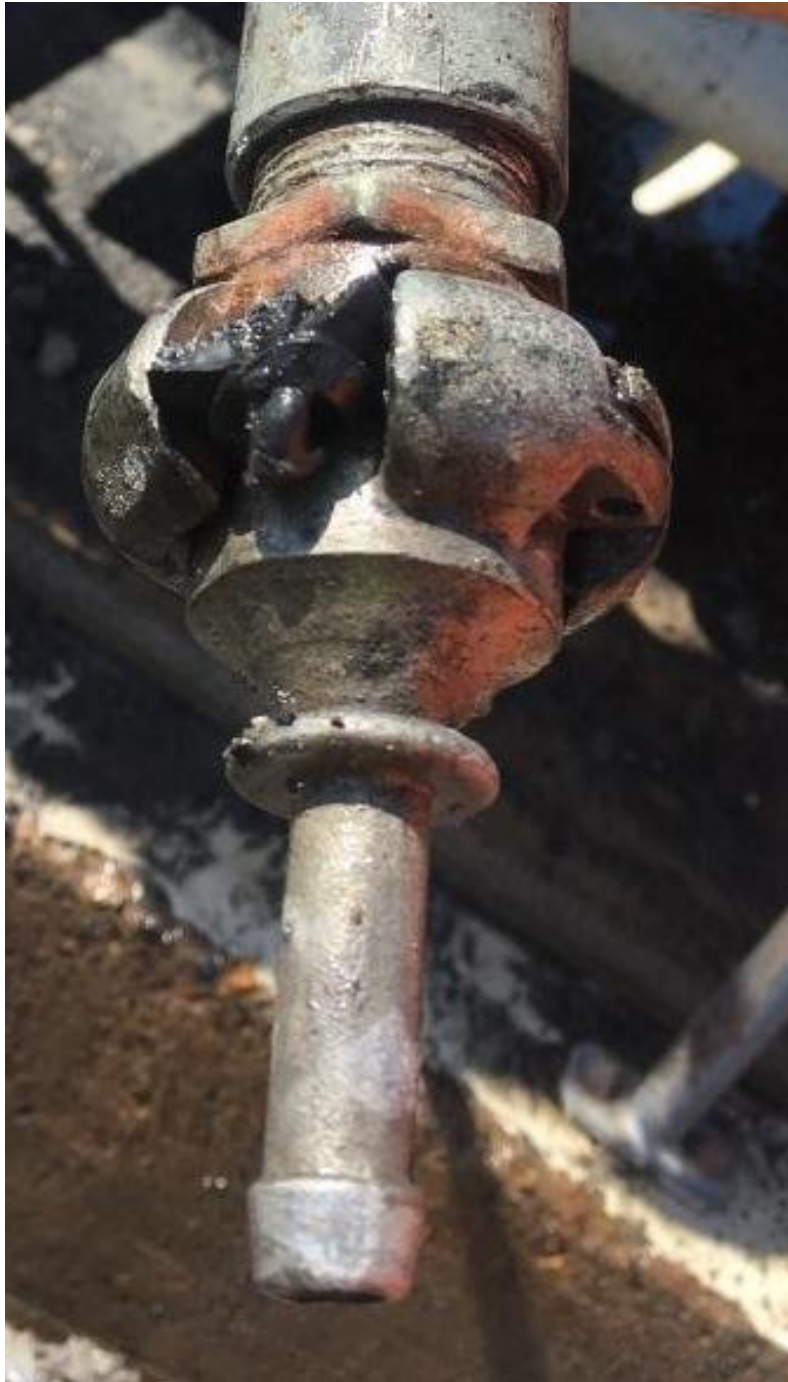
Not fit for purpose fitting used.

Elimination	All Industrial Services Units audited to ensure only company supplied fittings are used on vehicles – Remove any not - fit - for - purpose equipment if found on vehicles.
Substitution	Working with industry and equipment supplier
Isolation or barriers	
Engineering	All fittings and equipment to be in line with AS/NZS 4233
Administration	Review SWMS
PPE

Recommendations to industry: Mine operators and contract companies should review the use of non-genuine hoses, nozzles and fittings. Mine operators and contract companies should also review the training their workers have received in relation to the potential hazards associated with blockages in pressurised systems.
